DESIGN, CONSTRUCTION AND MAINTENANCE: FACTORS IN HOME MOISTURE DAMAGE IN THE SOUTHEAST

Linda L. Gardner, F. W. Fleming and Alan Griffith

Abstract

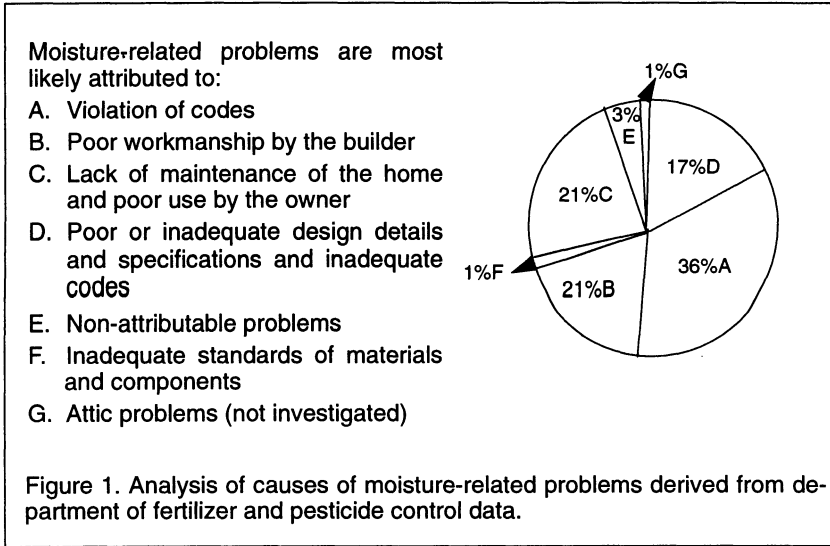
Problems cited in 1 and 2 are most likely attributable to one or more of the following categories, as illustrated in Figure 1:

- Violation of codes
- Poor workmanship by the builder
- Lack of maintenance of the home and poor use by the owner
- Poor or inadequate design details and specifications and inadequate codes
- Non-attributable problems
- Inadequate standards of materials and components
- Attic problems (not investigated)

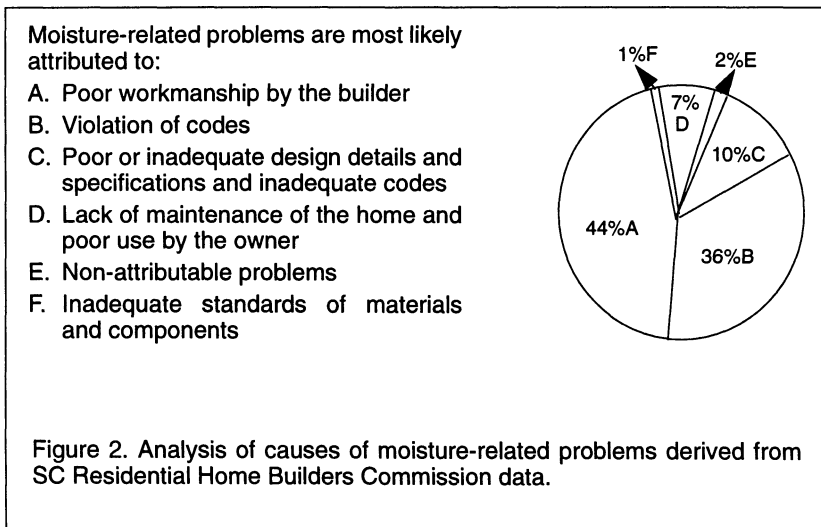
A similar list of problems has been derived from data of the SC Residential Home-builders Commission. Those problems can be attributed to a similar number of categories (see Figure 2).

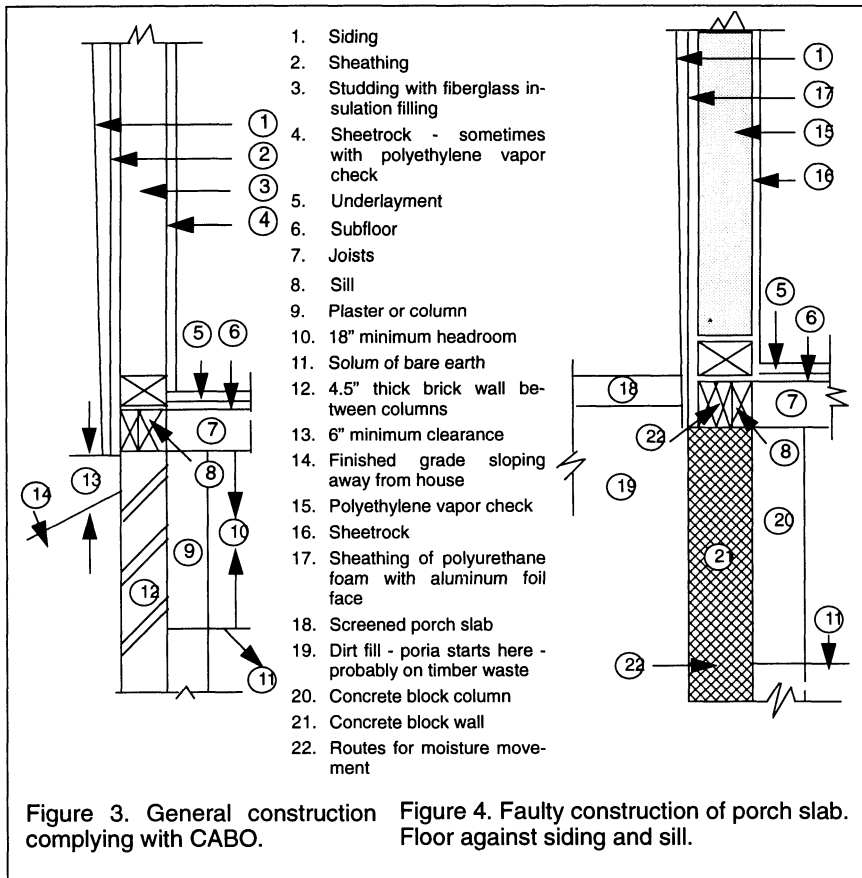
Another problem addressed was the presence of carport slabs, garages, driveways, screened porches, and similar structures, all with concrete floors and dirt fill against the side of a house with a crawl space. Here again there were code violations. The CABO (Council of American Building Officials, 1986) building code states that untreated wood siding should not be within 6 inches of the ground level. Figure 3 illustrates construction practice to comply with CABO.

In most instances, the finished surface of all types of slabs was the same as, or only a few inches below, the floor level of the house. This means that dirt fill carried up past the level of the structural sill and the siding. Moisture moved up from the ground and transferred to the timber, which rotted. Not only did the sill rot, but so did the siding and the wall studs. One house examined had been attacked by *Poria incrassata*, a virulent fungal growth. The fungus started in the sill in a dirt filled screened porch, rotted out the floor joists for about 6 feet of their length, rotted out the floor adjacent to the porch and was attacking the wall studs to a height of 7 to 8 feet above floor level. Figure 4 illustrates the form of construction used in that instance.

The problem of dirt filled porch construction in one house examined could have been prevented at little or no extra cost if the builder had (a) utilized the detailing noted in Table 2, and (b) linked the wall surface coating to the dampproof course (The Building Standards [Scotland] Regulations, 1981). Figure 5 illustrates this recommended simple construction technique. The house examined had only a loose polyethylene vapor retarder, inadequate ventilation, a crawl space level below the exterior ground level, and no coating of the external walls.
