A Post Occupancy Evaluation Of The Fourplex Condominium

Carla Cooper
Bill Sims

The Study

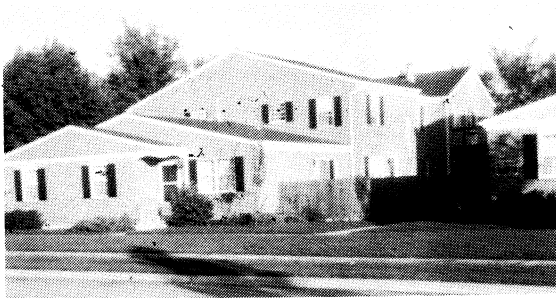
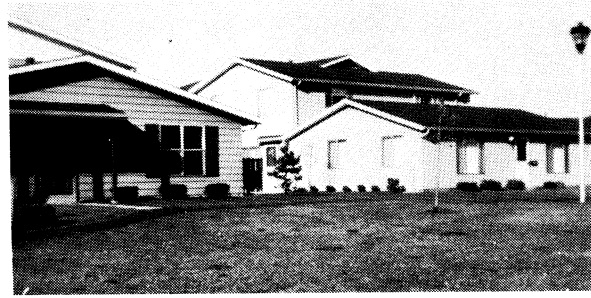
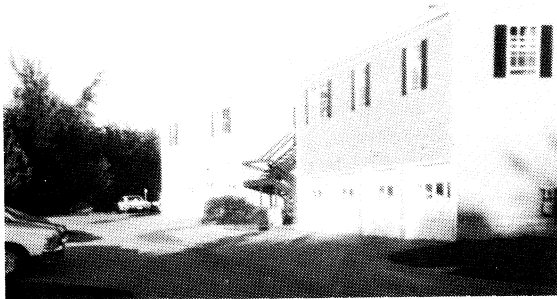
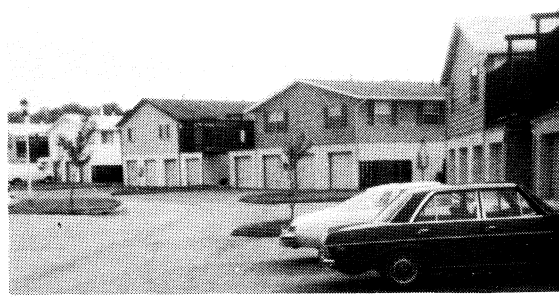
Figure 3. Front and Back Views of Fourplex Condominiums

Peppertree

Kimberly Villas

Peppertree parking area

Kimberly Villas parking area
